LAKE HOPATCONG DAM

NJ 00327

**PHASE 1 INSPECTION REPORT
NATIONAL DAM SAFETY PROGRAM**

April, 1979

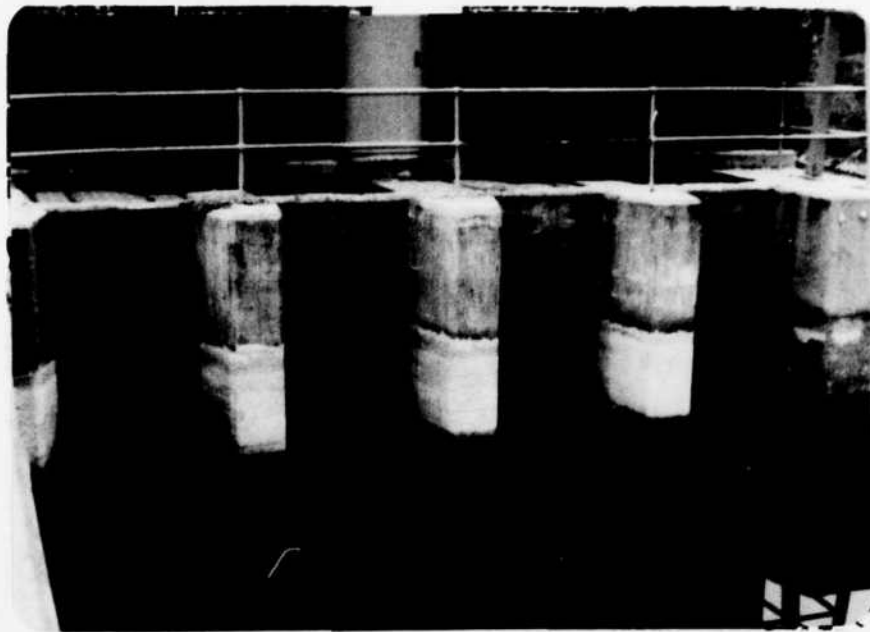
Gatehouse intake tunnels. Note trash racks not in place.

- 5. Repair deteriorated right sidewall of spillway discharge channel and asphalt pavement of fountain discharge channel. This should be done soon.**
- 6. Clean and install trash racks in gatehouse forebays. This should be done soon.**
